SUMMARY OF PROPOSED LEGISLATION

RE: AN ACT RELATING TO THE LAW AND ORDER COMMITTEE, THE HEALTH, EDUCATION, AND HUMAN SERVICES COMMITTEE, THE RESOURCES AND DEVELOPMENT COMMITTEE, THE BUDGET AND FINANCE COMMITTEE, AND THE NAABIK'IYATI' COMMITTEE, AND THE NAVAJO NATION COUNCIL; ESTABLISHING THE "NAVAJO NATION ENVIRONMENTAL REMEDIATION FUND" AND APPROVING A 2% ANNUAL SET-ASIDE FROM THE GENERAL FUND TO PAY FOR REMEDIATION ACTIVITIES AT CONTAMINATED SITES LOCATED ON THE NAVAJO NATION

Fact sheet for Presentation to
The 24th Navajo Council
12/16/2022

By Pam Maples, Remedial Project Manager
Navajo EPA Superfund: Brownfields Program

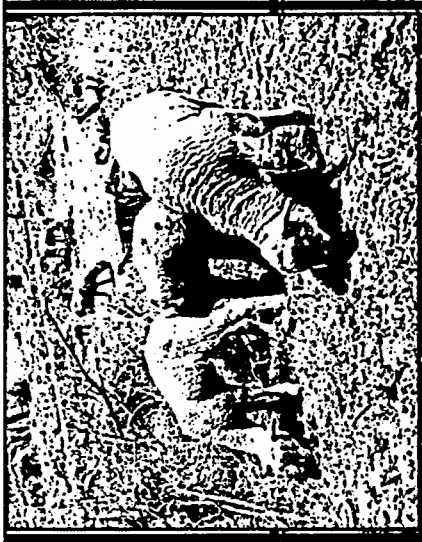
Black Creek is eroding the facility dump
Children playing in the creek, sheep grazing on vegetation in the flood plain, Creek water used for irrigation.

Water Contamination, Soil & Sediment Contamination:
Hexavalent Chromium confirmed at levels exceeding the screening level for protection of groundwater.
We have not yet sampled for other contaminants.

- Children play in the creek, livestock drink the water and eat the vegetation that grows along the banks of the stream. The creek water is used for irrigation for kitchen vegetables and crops. And to fill Red Lake.

- This major source of hexavalent chromium continues to erode and fall into the creek with every rain/snow melt event.

- A phased approach to characterize the soil in the creek and the flood plain will be needed to assess the extent of the hexavalent chromium and other contaminants in the soil and water of the entire drainage west and south of the site.

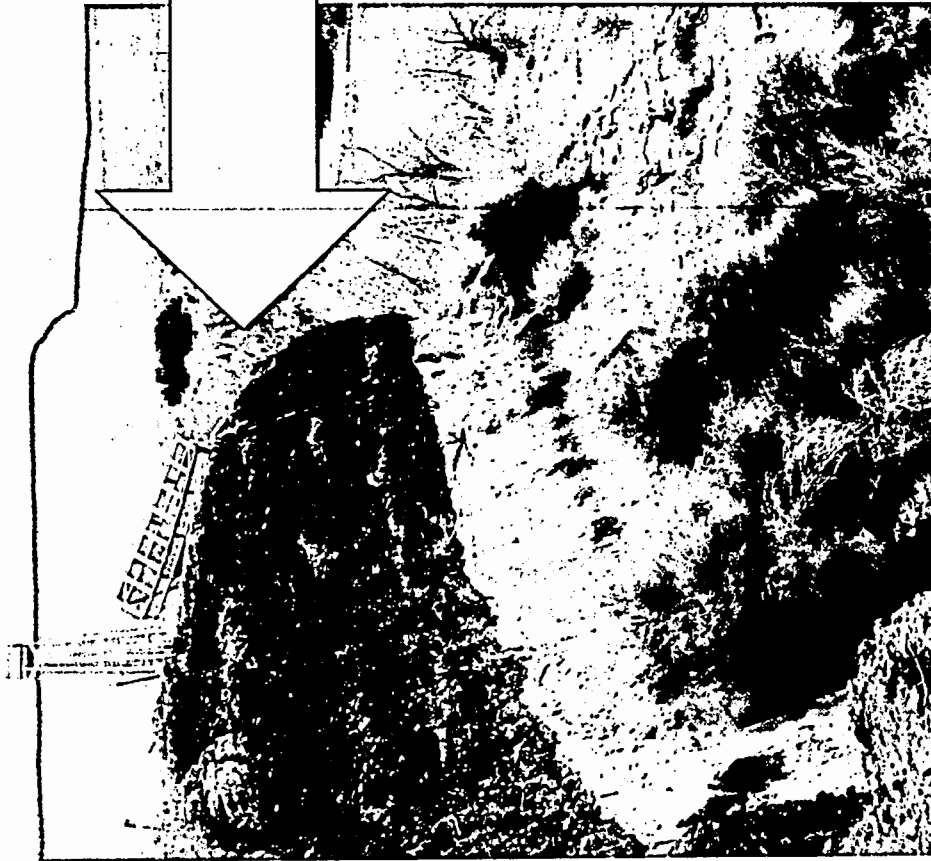
**An Area of Comingling of Contaminates
Groundwater Contamination, Soil Contamination;
Petroleum, Asbestos, Hexavalent Chromium**

- Petroleum groundwater contamination approximately 2 acres (as of 2018). The shallow aquifer is at an average of 20 feet below ground surface.
- Two feet of Diesel fuel floating on top of the groundwater had been reduced to an inch or less by 2018. Fuel is likely re-accumulating since the initial reduction because the source soil is heavily contaminated. There has been no remediation activity at the site due to the pandemic, and lack of non-federal funding to hire a remediation contractor.

- Hexavalent Chromium has been found in the groundwater, the surface soil, and soil at depth very near the petroleum contaminated soil. It is probably co-mingled. It has recently been discovered in Black Creek to the north of the site and in the ditch that bounds the site on the east. Further investigation/delineation is needed.

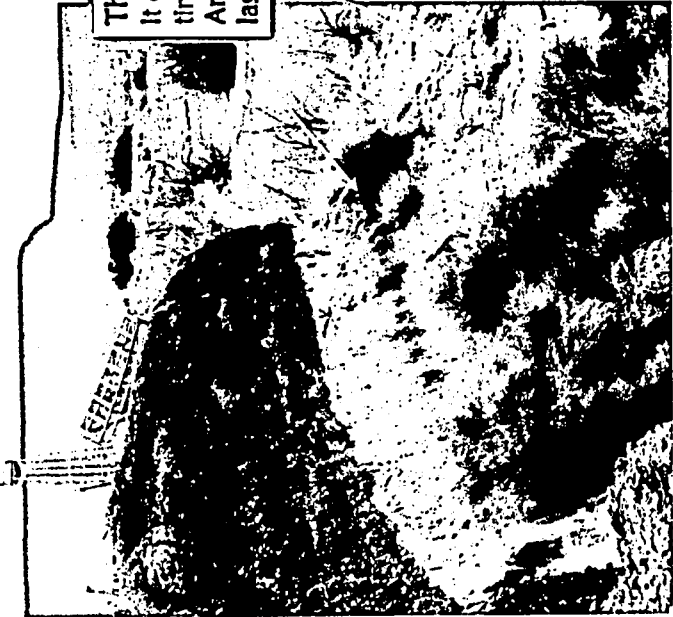
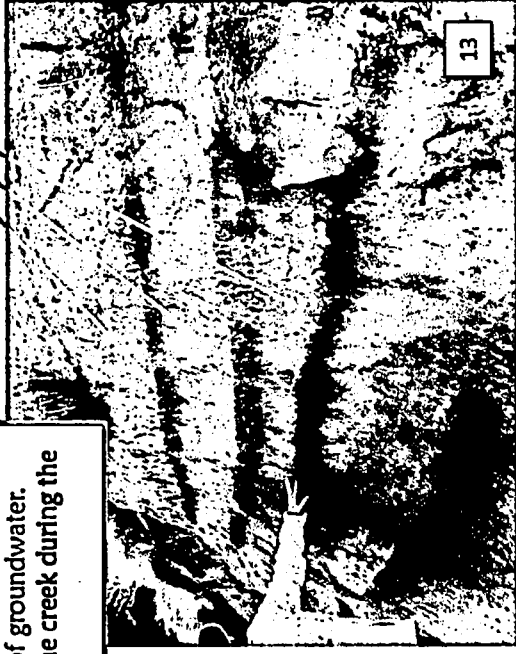
This pile (both pictures) is in the flood plain of Black Creek It contains dioxins and it contains hexavalent chromium at a level 15 times higher than that allowable for the protection of groundwater. Another 1,500 + cubic yards of this waste fell into the creek during the last monsoon season and winter.

Corrective Measures

1. Need to fund an emergency contract to pull the waste back from the rim of the wash ASAP.
2. That requires full closure of N-31 which is only (closed "on paper")
3. The resident on N-31 needs safe access to the paved road to the east so they don't have to use N-31 any longer.

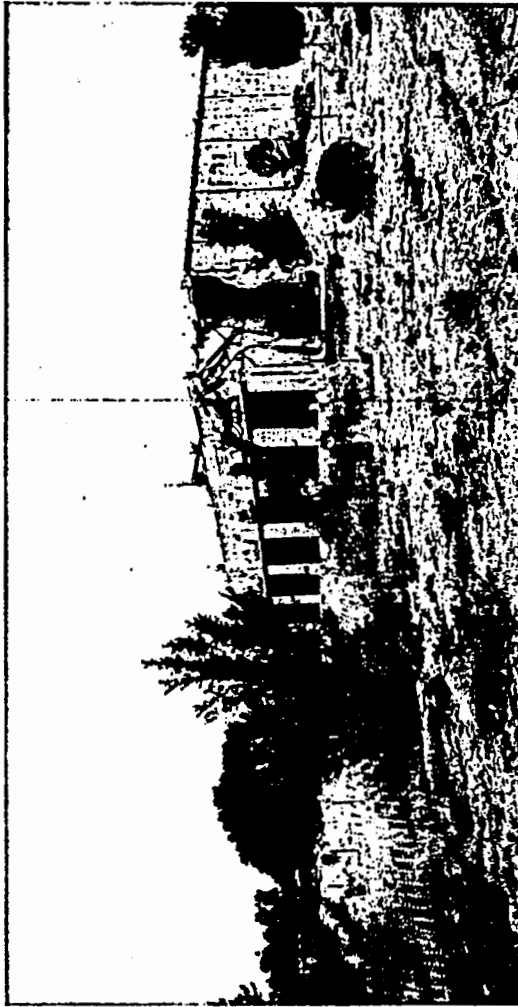
- There were large diameter Transit pipe fragments at the powerplant location and the cooling towers location. They were removed but there are piping and pipe fragments beneath the surface remaining in each area.
- The remaining underground piping for fire suppression and other transport of fluids throughout the 104 acre facility is either known as or suspected to be suspected to be Transit, an Asbestos Containing Material (ACM).
- ACM roofing material (some as much as 60% asbestos fibers) was present on the ground over much of the site and was concentrated at the lumber sales slab of PPI. An unknown quantity remains sub-surface in the area.
- Vermiculite insulation at the near surface and sub-surface remains in several areas of the site.
- Asbestos in soil remains commingled with the petroleum contaminated soil due to improper tear down of the power plant.

- The drums and totes of hazardous waste were removed during the TCRA summer 2021.
- The amount of remaining waste metal of all types littering the site is enormous.
- There are piles of heavy equipment tires.
- There are piles of the remains of all of the concrete foundations and slabs, some of which are contaminated by oil and grease deposits.
- There are pits, sumps, and manways that are traps for children and animals.

Surface Asbestos was addressed through a one-time Emergency Time Critical Removal Action through USEPA Superfund Region 9 (summer 2021)

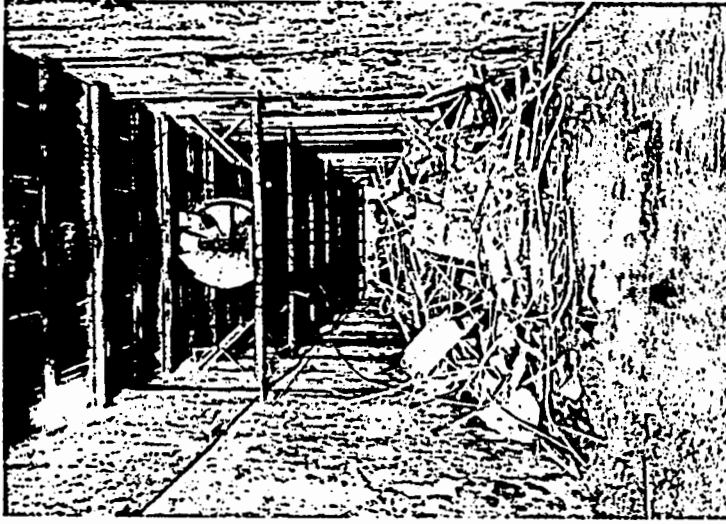
Physical hazards; the Particle Board Slab

The Particle board press sump is roughly 80' X 25' and is 15 feet deep at the edges with vertical sides. No ladders or other means of egress are to be seen in the sides. The sump is deeper in the center. This sump always has water in it, either completely full or down 3 feet or more as evaporation occurs.

- There is a greasy silty sheen on top of the water.
- There is dark oil staining of the concrete and soil along the southern and western edges of the sump.

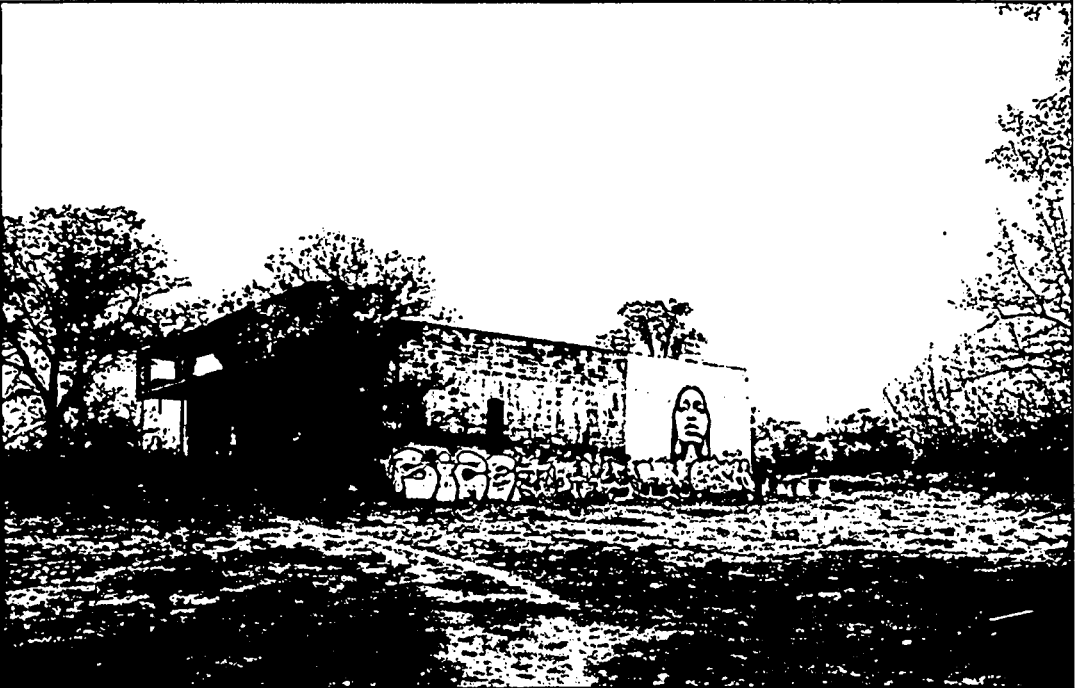
Project Name: Sawmill, AZ Asbestos		Site Location: Sawmill Chapter, Navajo Nation Sawmill, Apache County, Arizona	TO No.: 68HE0919F0081-20
Photo No. 1	Date: 9/30/2021

Direction Photo Taken: Southwest			
Description: Overview of the former Drying Kiln Building

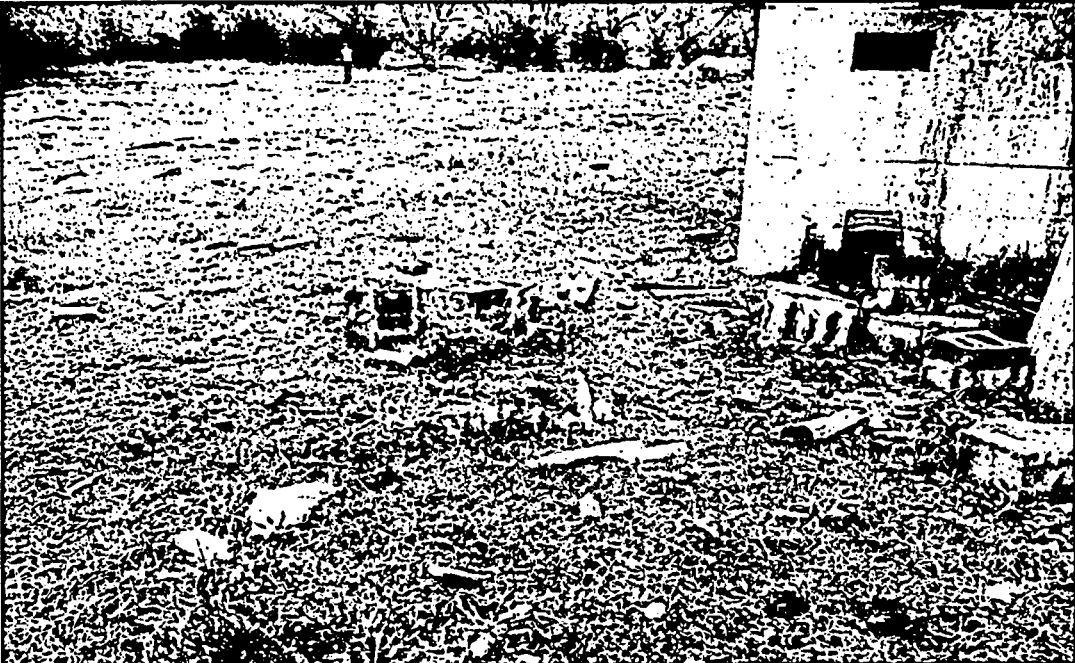
Photo No. 2	Date: 9/30/2021

Direction Photo Taken: East		
Description: Example of suspected ACM debris surrounding the former Drying Kiln Building

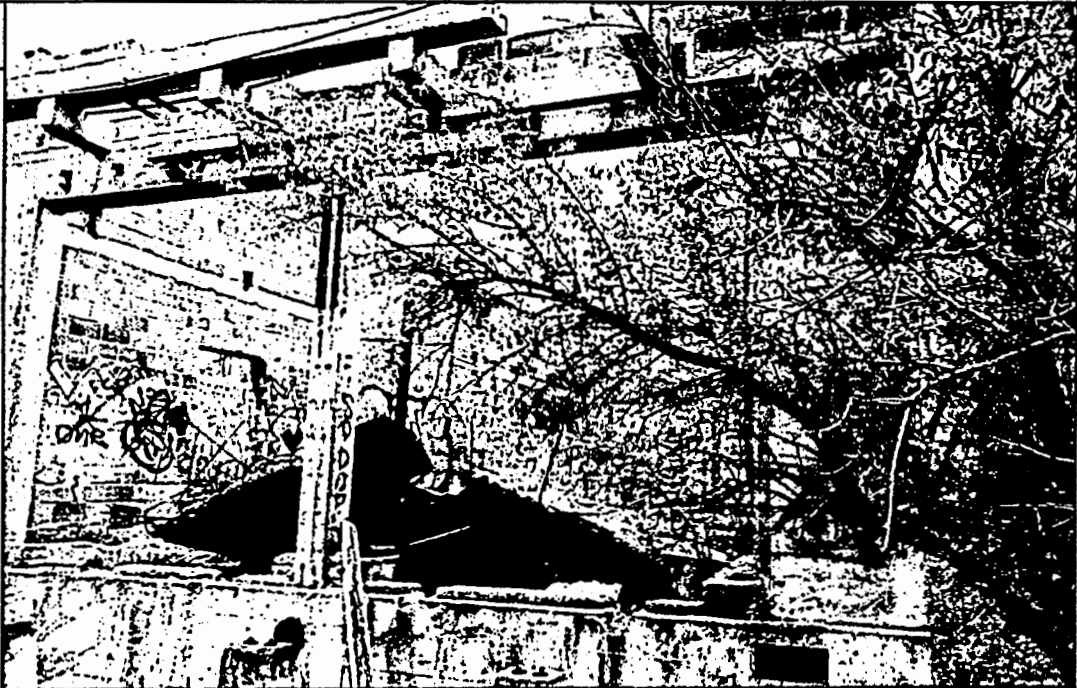
Photo No. 3	Date: 9/30/2021

Direction Photo Taken: West		
Description: View inside the former Drying Kiln Building showing collapsed roof

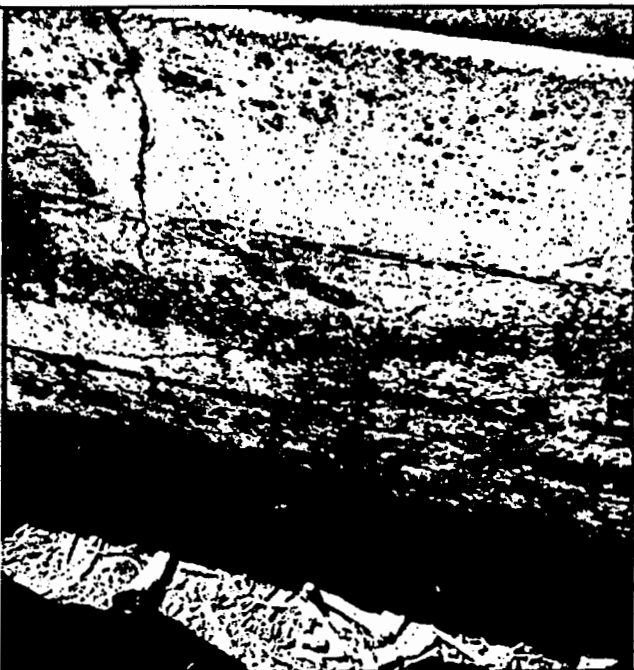
Photo No. 4	Date: 7/12/2022

Direction Photo Taken: North		
Description: Sample SAZ-BS-001, black membrane on trough west of the former Drying Kiln Building.

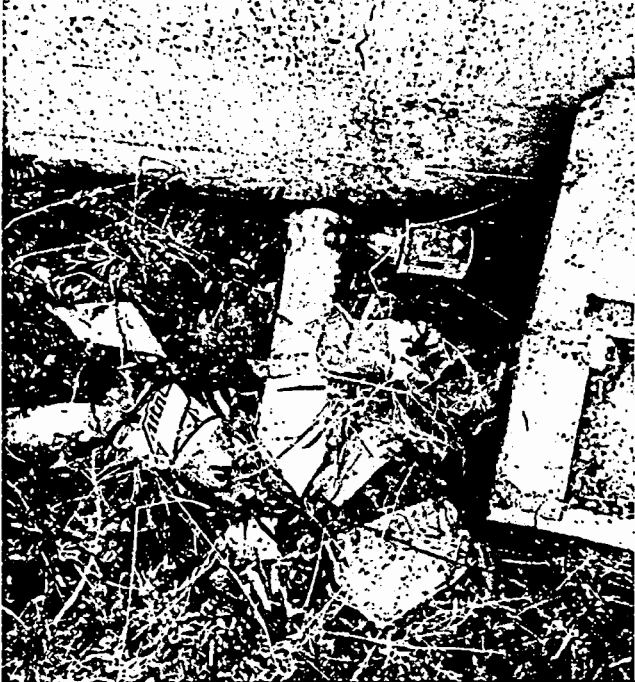
Project Name: Sawmill, AZ Asbestos		Site Location: Sawmill Chapter, Navajo Nation Sawmill, Apache County, Arizona		TO No.: 68HE0919F0081-20
Photo No. 5	Date: 7/12/2022

Direction Photo Taken: East				
Description: Sample SAZ-BS-004, corrugated roofing material adjacent to former Drying Kiln Building

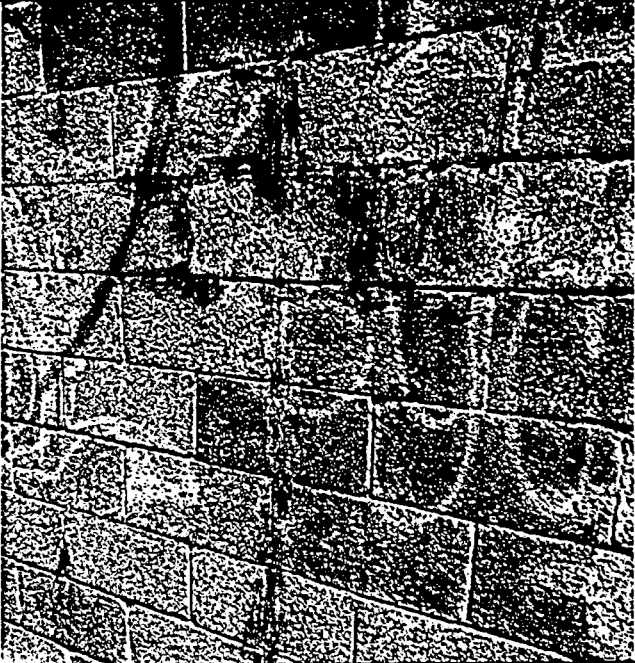
Photo No. 6	Date: 7/12/2022

Direction Photo Taken: North				
Description: Sample SAZ-BS-009, black sealant in cracks along the north wall of bay 2 in the former Drying Kiln Building
